title: INVESTIGATION OF MATERIALS FOR
SHIP-TO-SHORE LOW PRESSURE STEAM
HOSES

author: Thorndyke Roe, Jr.

date: July 1977

CIVIL ENGINEERING LABORATORY

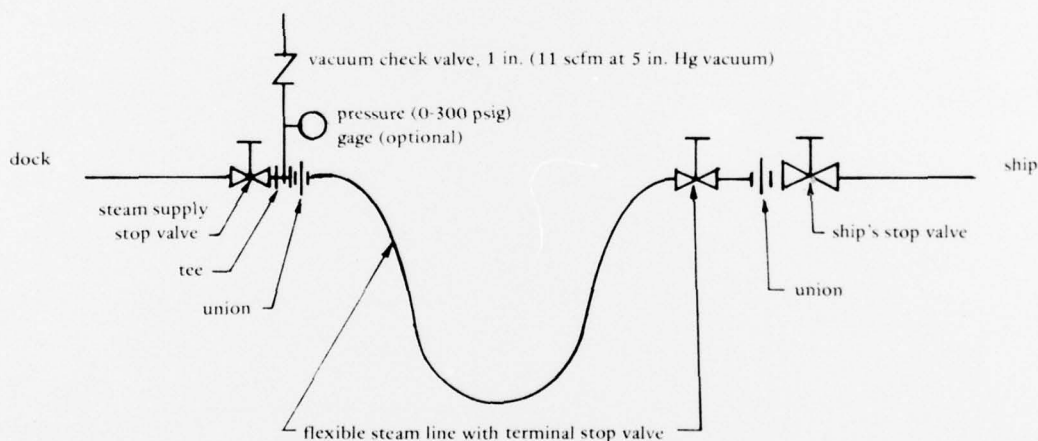
A procedure to prevent rapid pressure release in steam hose consists of: (1) closing both the ship's stop valve and the flexible hose terminating stop valve, (2) disconnecting union at ship's line between valves, (3) closing dockside stop valve, and (4) allowing hose to cool slowly, with the vacuum check valve preventing pressure inside the hose from dropping below atmospheric. The hose and valve system is shown schematically in Figure A-1.

Figure A-1. Steam hose and valve system.

The rate of decrease in internal pressure will depend upon the heat loss from the hose section, but it should take less than 5 minutes to reach one atmosphere. If pressure decrease appears to be too rapid one could crack the dockside steam valve and bleed the steam into the hose to slow the rate of pressure decrease.
